**ASOCIACIÓN LATINOAMERICANA DE CONTROL DE CALIDAD
PATOLOGÍA Y RECUPERACIÓN DE LA CONSTRUCCIÓN
BOLIVIA**

**Coloquio
Internacional
de Patología Estructural**

COLAPSO ESTRUTURAL

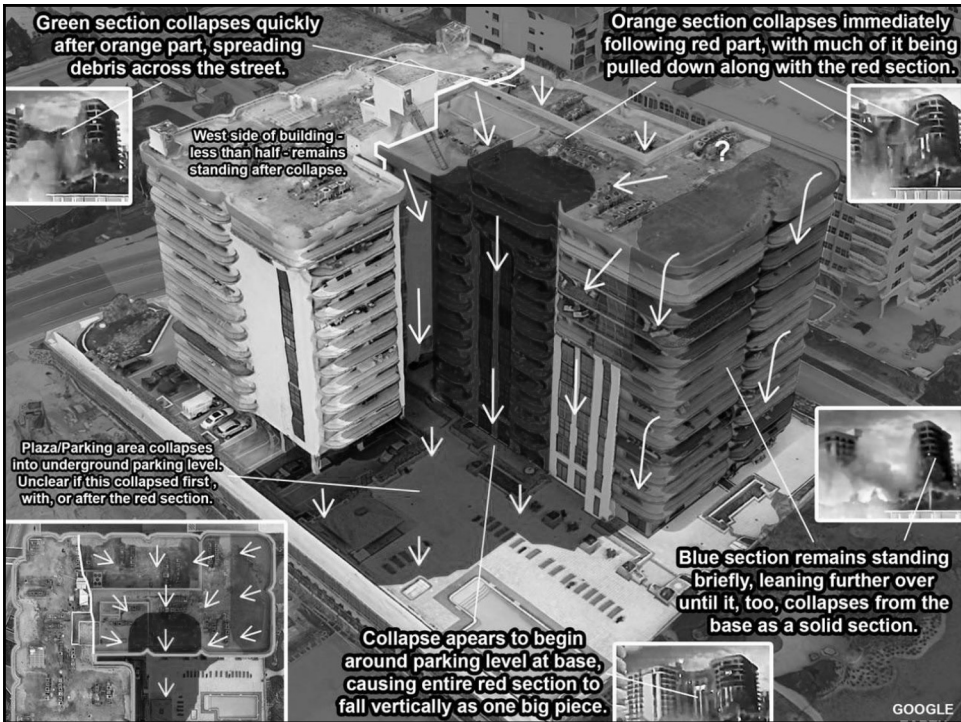
Green section collapses quickly after orange part, spreading debris across the street.

Orange section collapses immediately following red part, with much of it being pulled down along with the red section.

West side of building - less than half - remains standing after collapse.

Plaza/Parking area collapses into underground parking level. Unclear if this collapsed first, with, or after the red section.

Blue section remains standing briefly, leaning further over until it, too, collapses from the base as a solid section.

Collapse appears to begin around parking level at base, causing entire red section to fall vertically as one big piece.

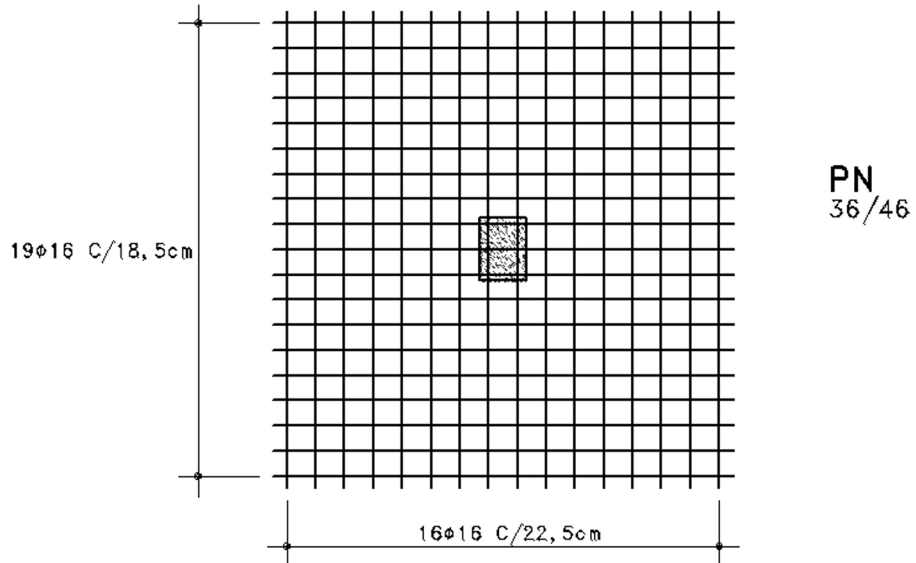
Refuerzo SUPERIOR columnas 36x46 cm
Losa área lazer, plana, sin capitel

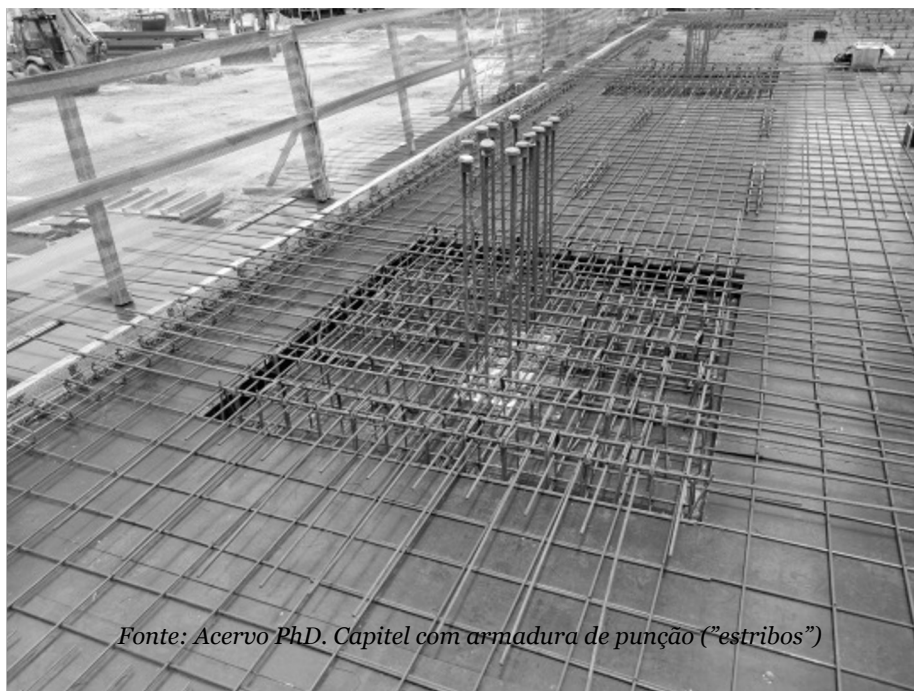
Fonte: Acervo PhD. Capitel com armadura de punção ("estribos")

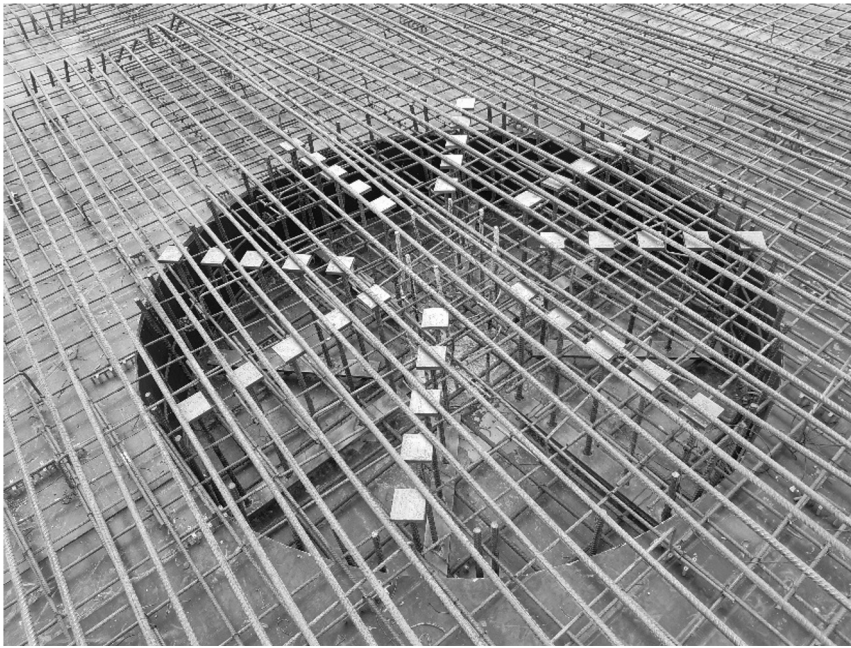
Fonte: Acervo PhD. Capitel com armadura de punção (“studs”).
