*Fire and Collapse of the Wilton Paes de Almeida
Building
Lessons Learned*

Paulo Helene
*PhD Engenharia Director
IBRACON Technical Director
Prof. Universidade de São Paulo
ALCONPAT Internacional, past President
Member fib (CEB-FIP) Model Code for Service Life Design*

**Fire and Collapse of the Wilton Paes
de Almeida Building**
Lessons Learned
53 years old
collapsed in 1 h 20 min

São Paulo May, 1st 2018

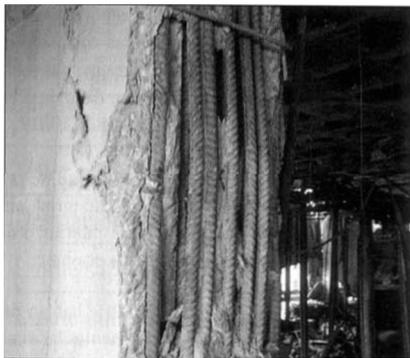
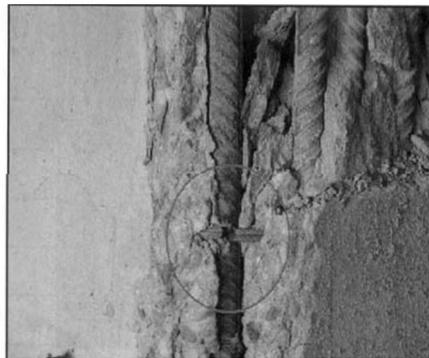
“the reinforced concrete structure, columns, beams and slabs under 16 hours severe fire condition could perform well and no collapse”

... “the penetration of the damaged, is heterogeneous and vary from 1.5 cm in 19th floor to 3 cm in 12th floor...”

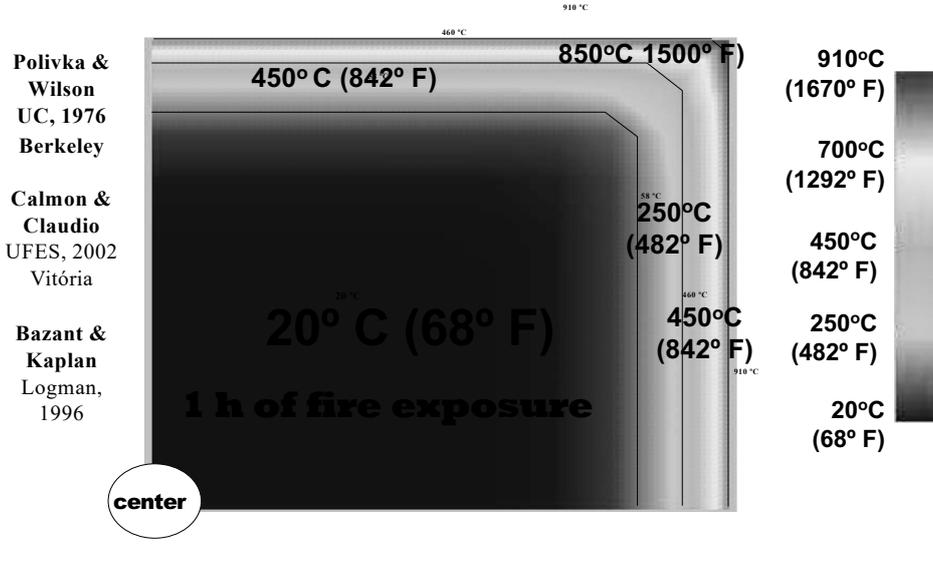
Temperature rise for a 50 x 50 cm (20 x 20 inches) concrete column

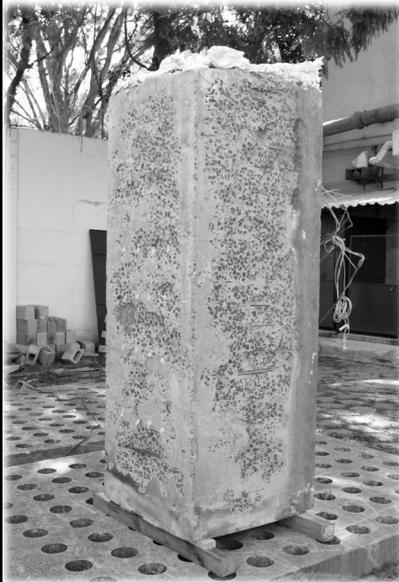
Mockup integrity after 180 minutes

- ✓ only shallow spalling observed;
- ✓ start: 36 minutes (initial);
- ✓ “popping” sound, then it stops;
- ✓ intact edges;
- ✓ depth: from 0 to 48 mm (0 to 2 in)
- ✓ average spalling: 9,3 mm (3/8 in)

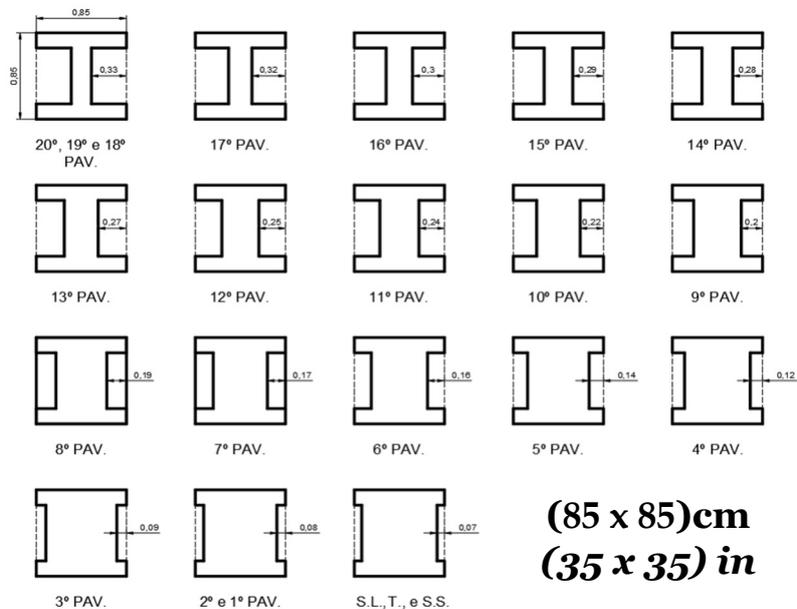
Cross section of columns in each floor

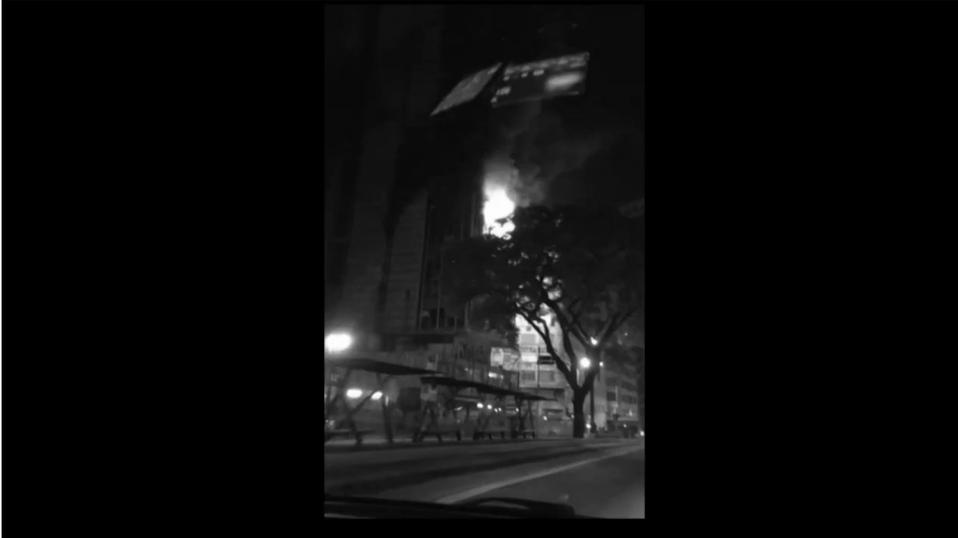
fire start at 1:30 AM (video)

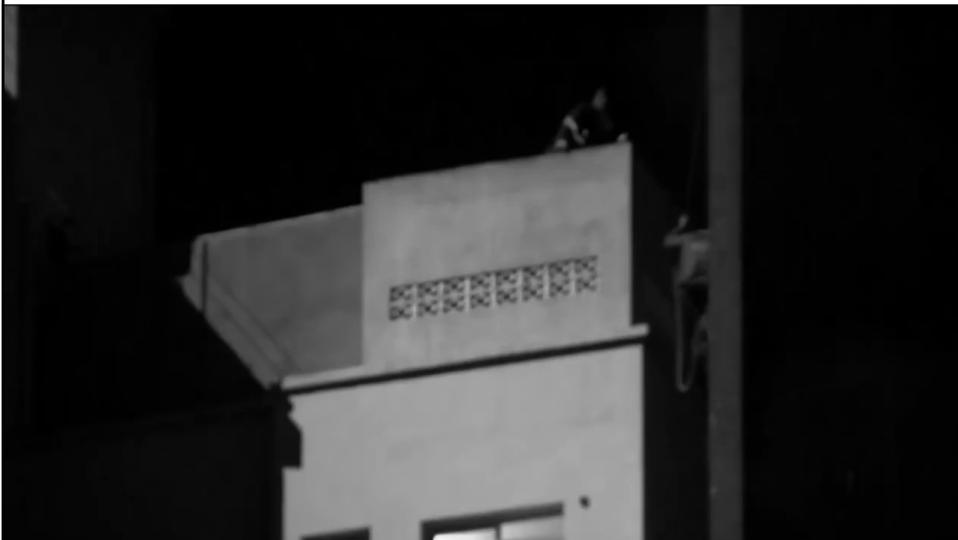
Collapse at 2:50 AM (video)

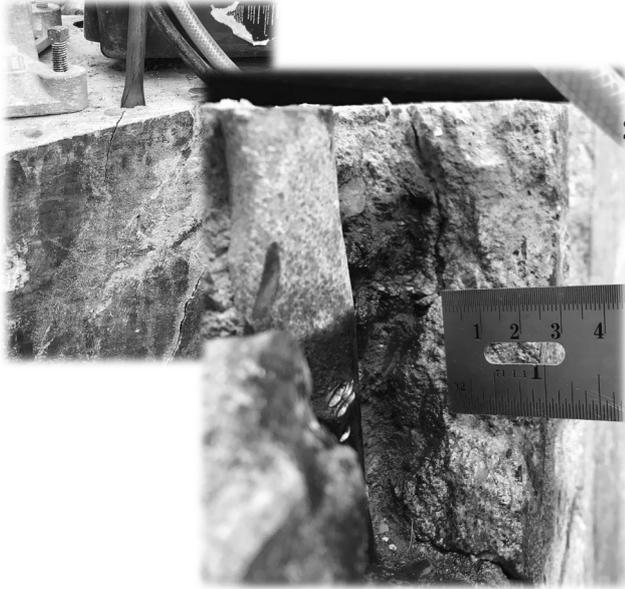
Carbonation depht

2,5 cm to 3,0 cm

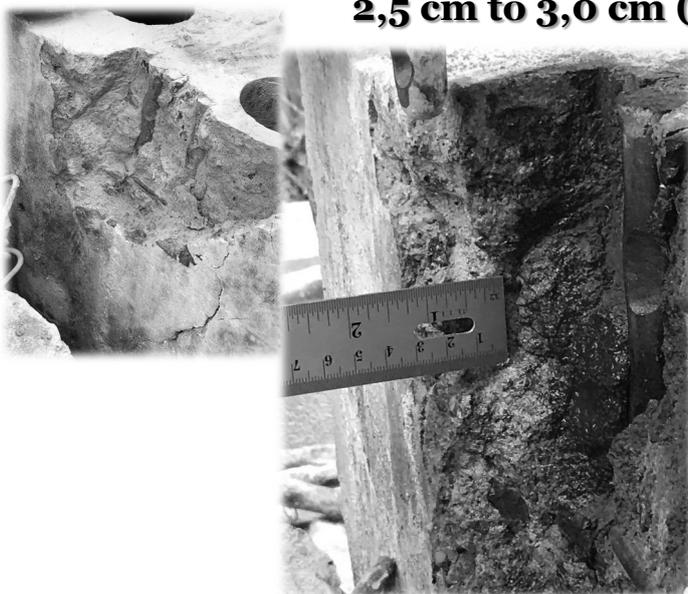
Carbonation depht

2,5 cm to 3,0 cm (1 to 1 1/2 in)

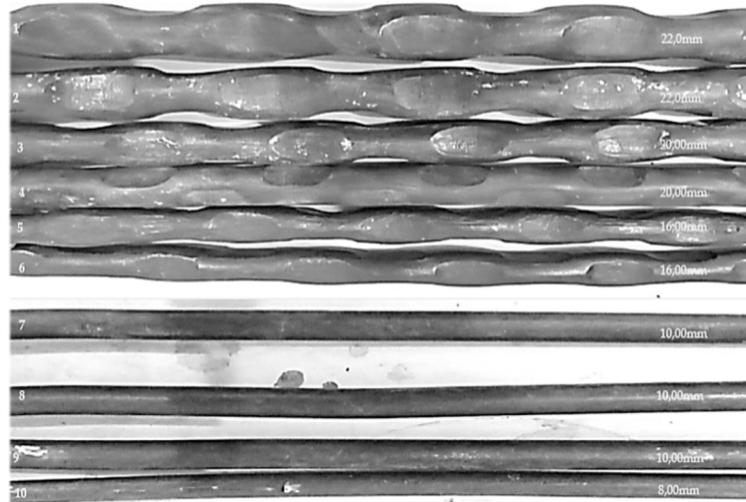
Notched rebars with diameters of 22, 20 e 16 mm (1, 3/4 and 5/8 in) CA 60
Stirrups with diameters of 8 e 10 mm (5/16 and 3/8 in) CA 37

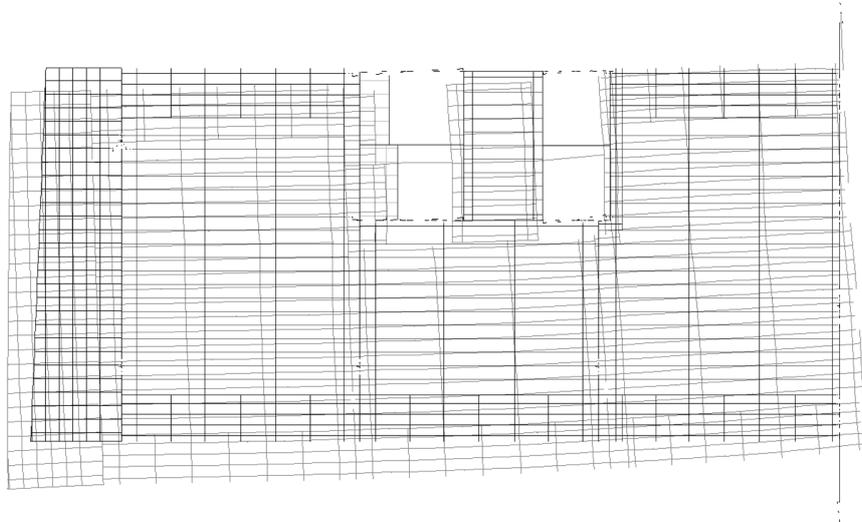
Torsion due the vertical load, thermal load and wind of the day of collapse.
