## THE STRENGTHENING OF TUBULAR CENTRIFUGED CONCRETE POSTS USING MBRACE SYSTEM – A NATIONAL PROBLEM

Paulo Helene  
*President of Brazilian Concrete Institute – IBRACON*  
*Full Professor, University of Sao Paulo – USP*  
Paulo Barbosa  
Fernanda Pereira

November, 3<sup>rd</sup>, 2005

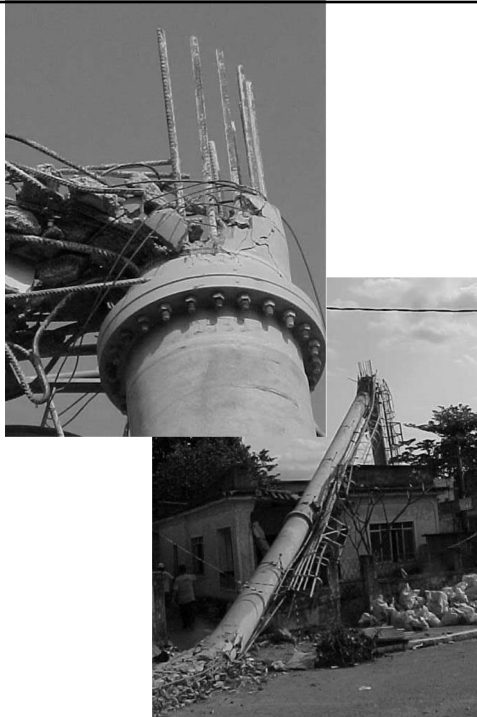
- Some of the posts collapsed after a few years of use with four of these cases being confirmed in the states of Sao Paulo, Espirito Santo, Rio de Janeiro and Rio Grande do Sul;
- In each of the known collapses, the failure occurred within the development length between the first module (fixed to the ground) and the second module.

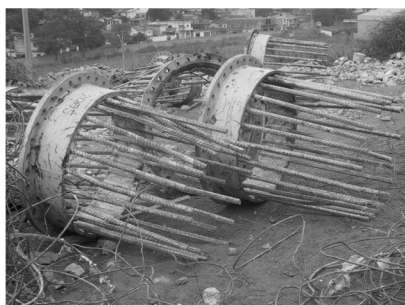
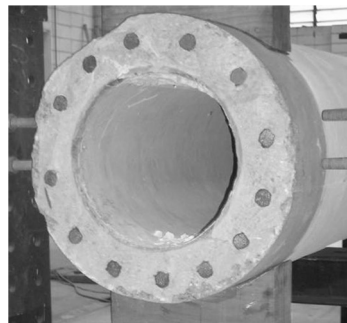
- The most significant problem encountered in such structure, was its inadequate percentage of reinforcement at the joint area, between 8.5% and 18.2%;
- These rates exceed considerably the maximum reasonable limit, which among other reasons guarantees adequate conditions for stress transfer.

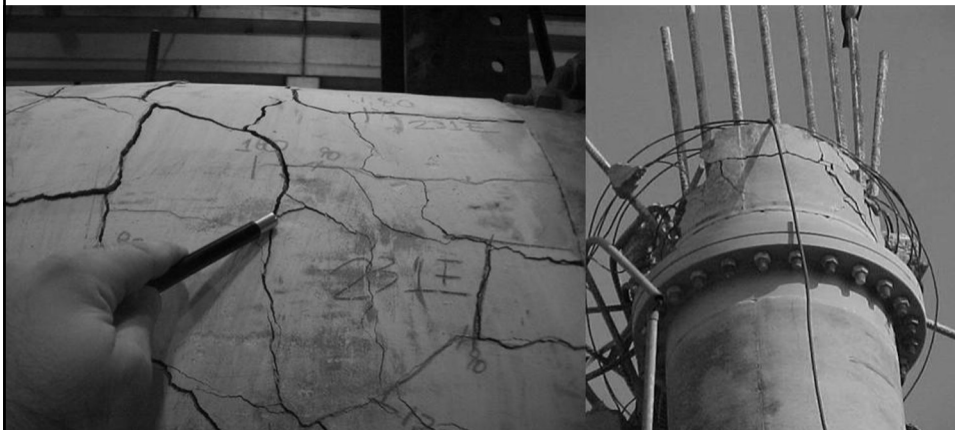
- All of the tests carried out with non-reinforced posts presented a failure mechanism very close to those found in the posts that collapsed.

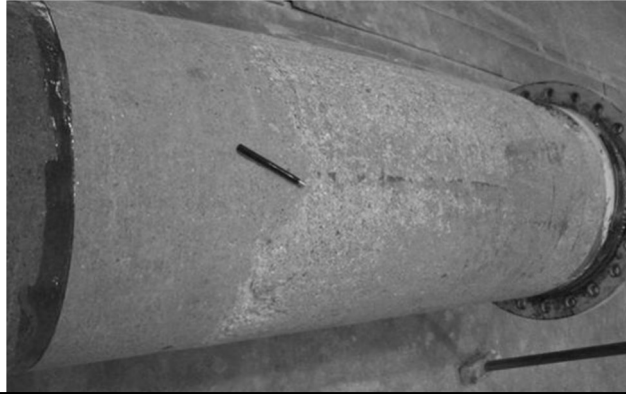
- The failures that occurred in the newly reinforced poles in the joint region developed due to flexure in the Section III domain without any deterioration of the joint area, proving the efficiency of the proposed reinforcement;
