Sixth International Conference  
**CONCRETE UNDER SEVERE CONDITIONS**  
*Environment and Loading*

### **HIGH STRENGTH COLORED REINFORCED CONCRETE UNDER STANDARD FIRE EXPOSURE**

**Paulo Helene**

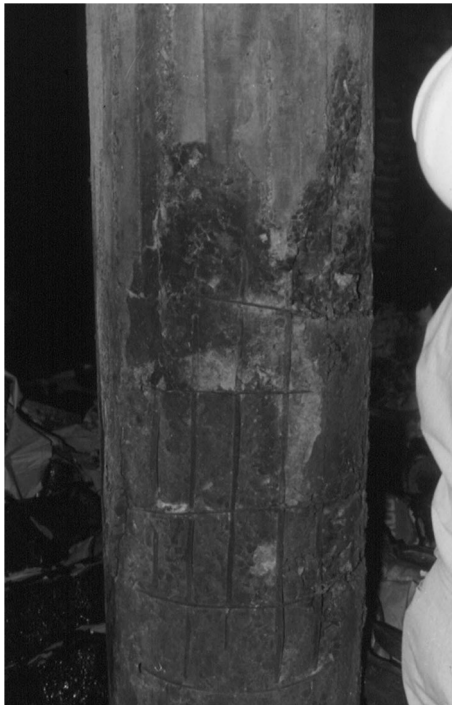
**typical  
columns  
remaining  
aspect**

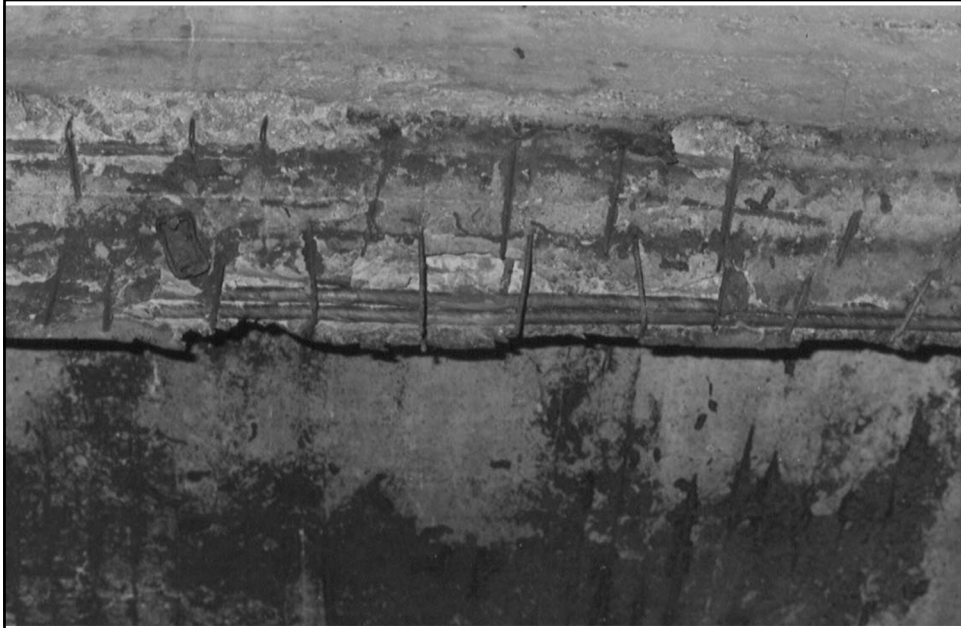
**typical beams aspect**

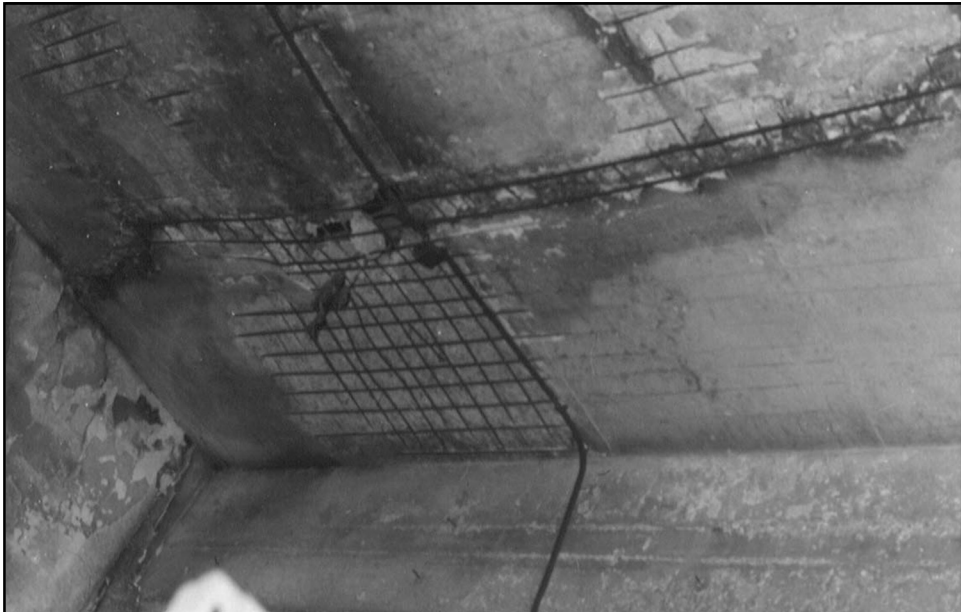
**typical slabs aspect**

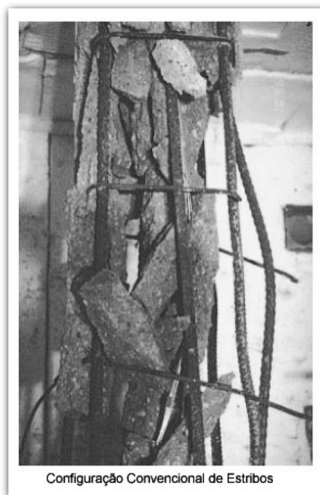
**incorrect**

## *stirrups in columns*

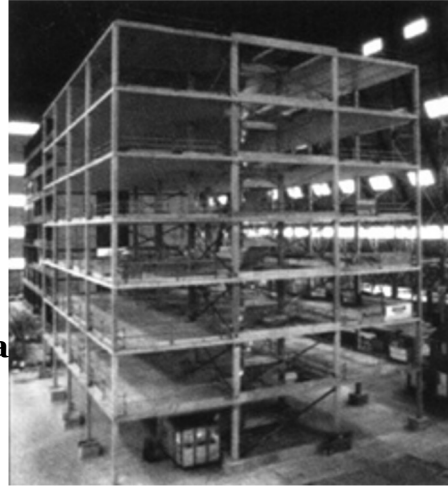
Cardington Concrete Building Frame

- ✓ 7 stories
- ✓ 25m high
- ✓ slab → 15cm  $f_{ck} = 37\text{MPa}$
- ✓ beam → 2cm  $f_{ck} = 74\text{MPa}$
- ✓ column → 4cm  $f_{ck} = 100\text{MPa}$
- ✓ calcáριο and granite
- ✓ RH > 80%

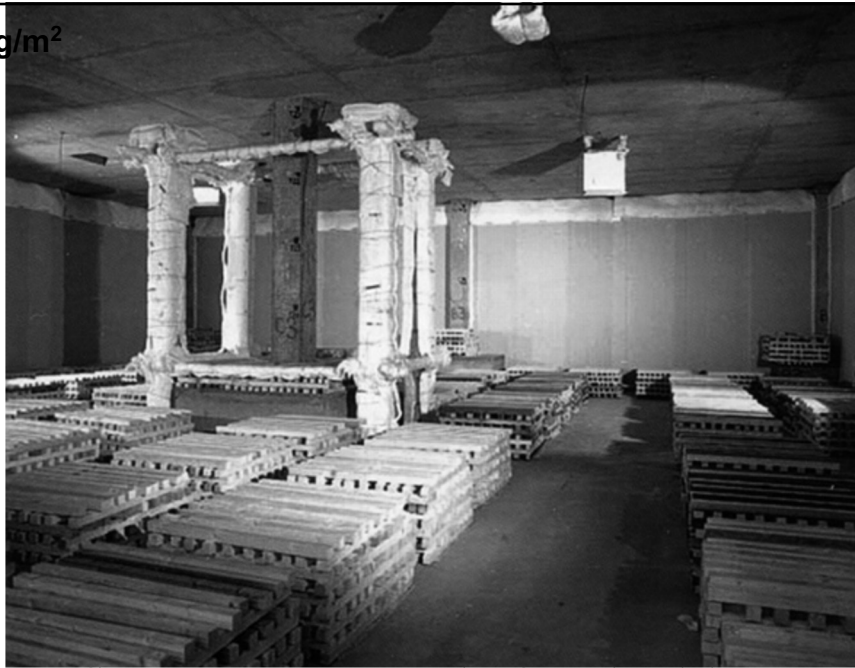
40kg/m<sup>2</sup>

fire compartment before ignition.

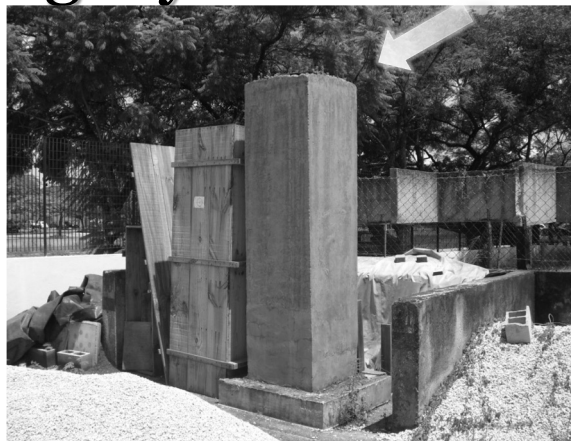
lab column at natural  
environmental exposure  
during 8 years

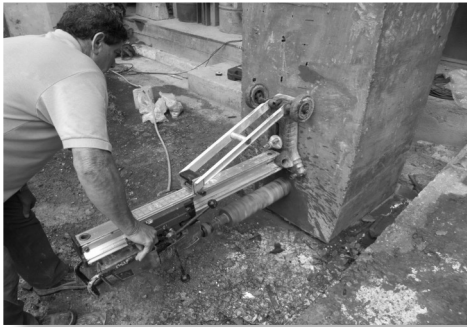
## cores extraction

**140 MPa**

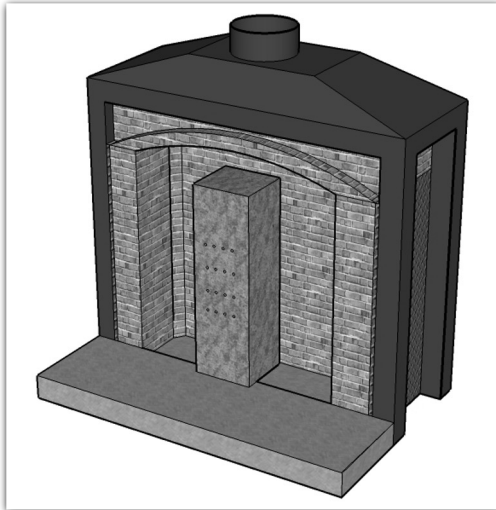
## Lab Test

✓ **unloaded**

✓ **3 sides**

✓ **ISO 834**

✓ **180 min**

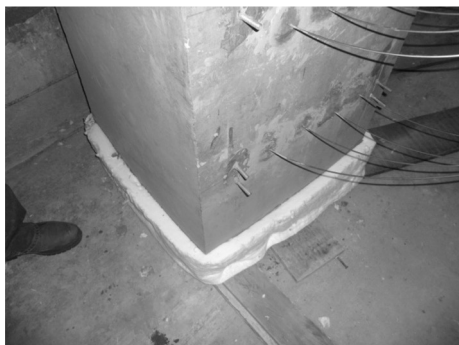
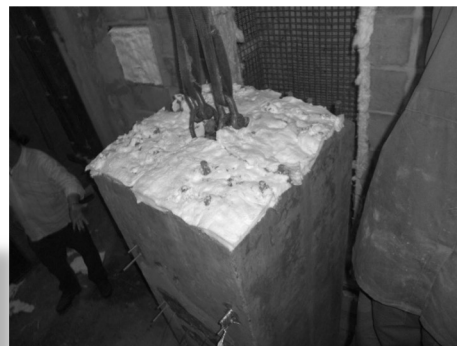
## Top protection with ceramics fiber

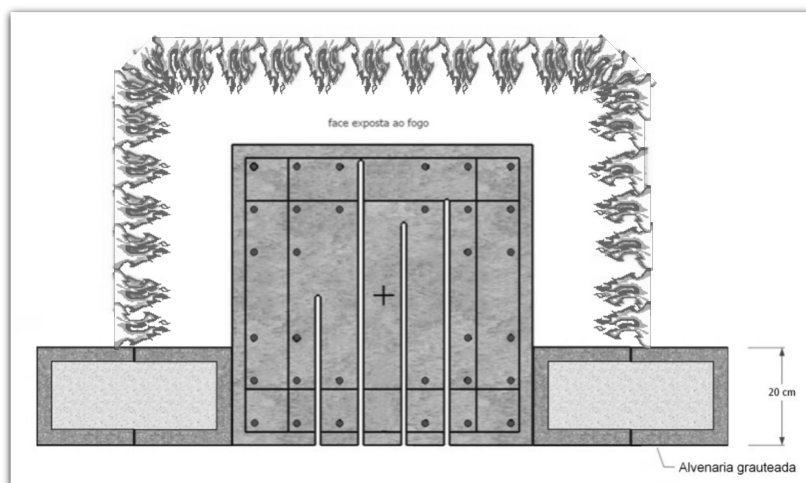
## Heat Conditions (3 sides)

*ISO 834 standard fire*

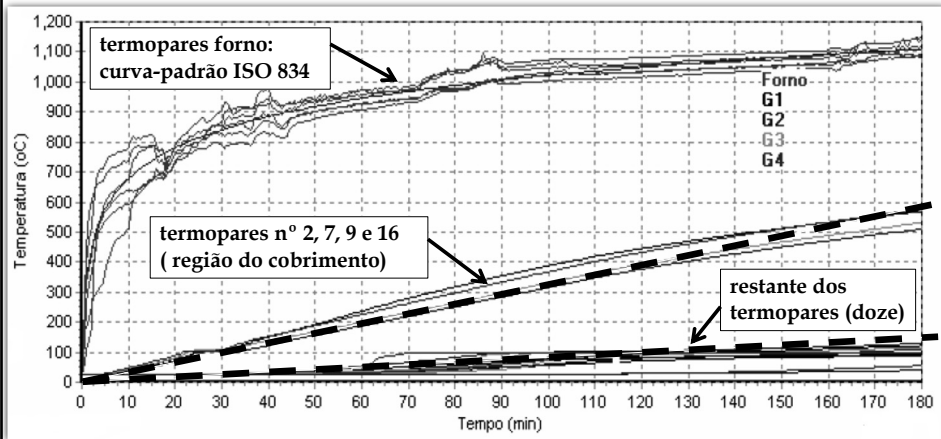
## temperature evolution

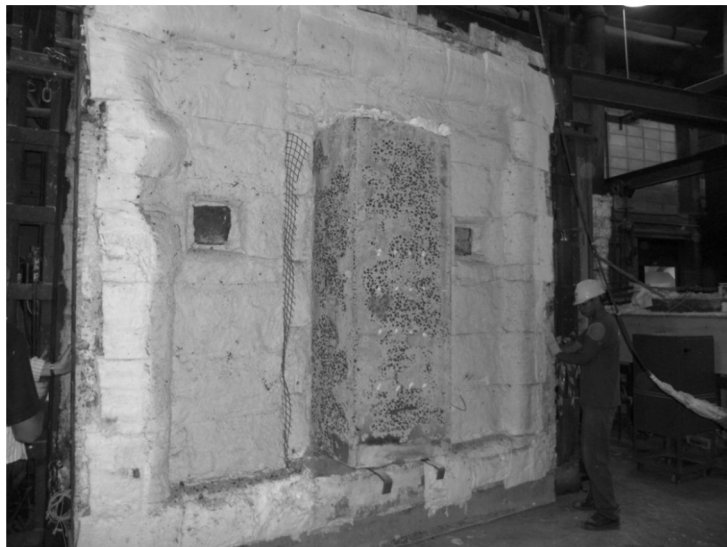
## After Lab Test 180min fire + 3 days

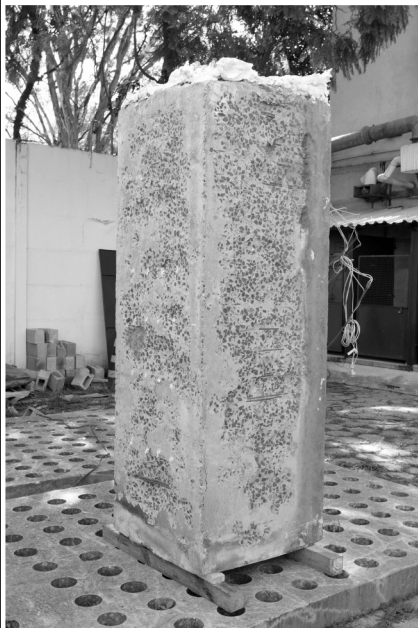
# Integrity after 180min

- ✓ ***spalling*** no explosive
- ✓ **pop corn sounds < 36min**
- ✓ **uniform distribution**
- ✓ **< 48mm (deep)**

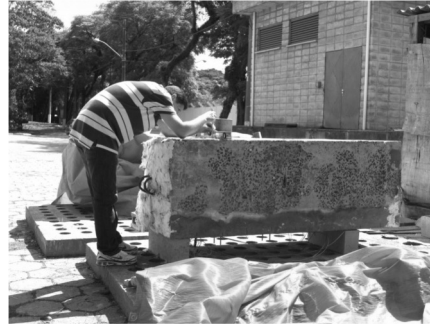
*spalling* measured in 450 points (150 each side)

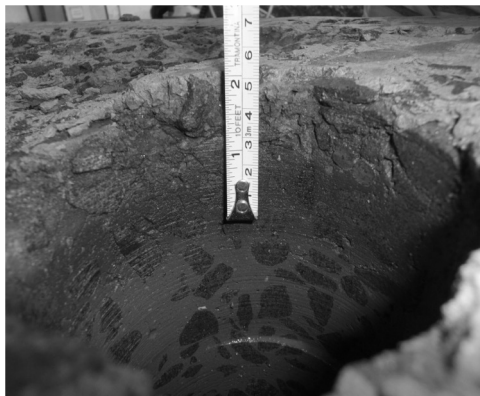
- ✓ red pigment
- ✓ deep  $\approx 55\text{mm}$
- ✓  $\text{Fe}_2\text{O}_3$  em  $\text{Fe}_3\text{O}_4$
- ✓ hematite to magnetite

about  $600^\circ\text{C}$

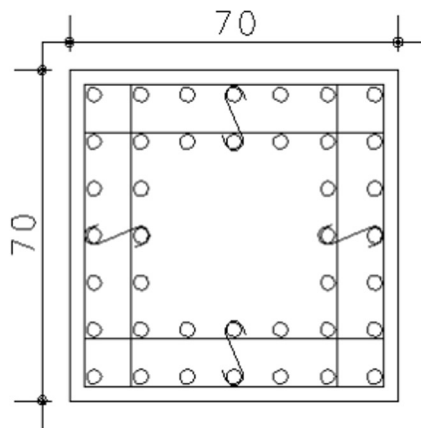
cross section = 70x70cm  
 $A_c = 4578,32\text{cm}^2$   
 $A_s = 40 \text{ } \varnothing 32\text{mm} = 321,68\text{cm}^2$   
 $\rho = 7,03\%$

Hipótese de Cálculo  
(Contraventamentos)

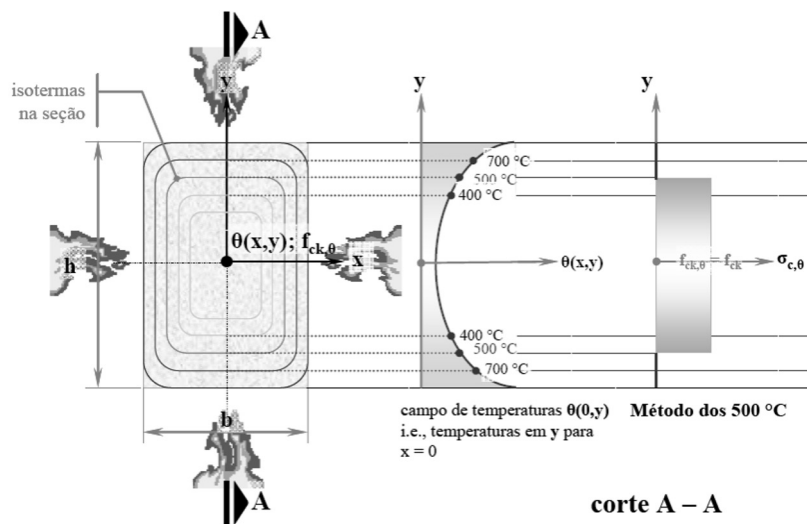
## 500°C Isotherm Method . EN 1992-1-2-2004 (EUROCODE II)

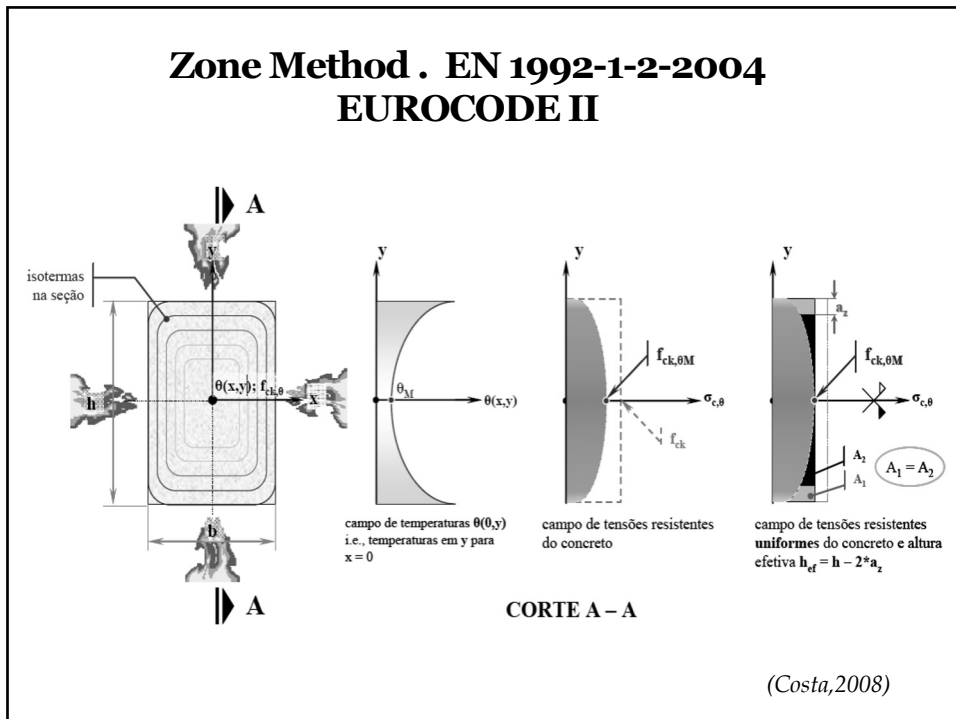
## Zone Method . EN 1992-1-2-2004 EUROCODE II

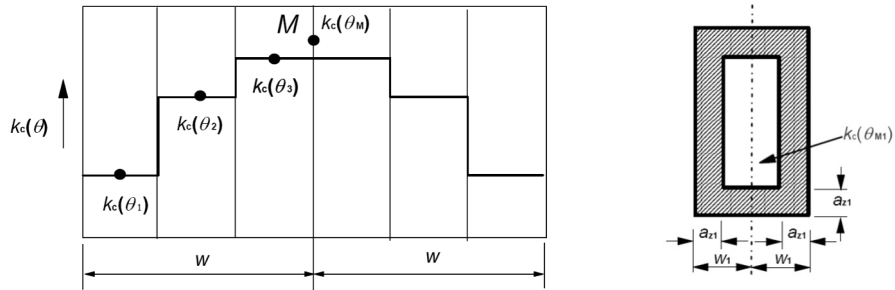
## Zone Method . EN 1992-1-2-2004 EUROCODE II

$$a_z = \begin{cases} w \cdot \left( 1 - \frac{\kappa_{c,m}}{\kappa_{c,\theta_M}} \right) & \rightarrow \text{lajes e vigas;} \\ w \cdot \left[ 1 - \left( \frac{\kappa_{c,m}}{\kappa_{c,\theta_M}} \right)^{1,3} \right] & \rightarrow \text{pilares e pilares - parede.} \end{cases}$$

$$\kappa_{c,m} = \frac{\left( 1 - \frac{0,2}{n} \right)}{n} \cdot \sum_{i=1}^n \kappa_{c,\theta_i}$$

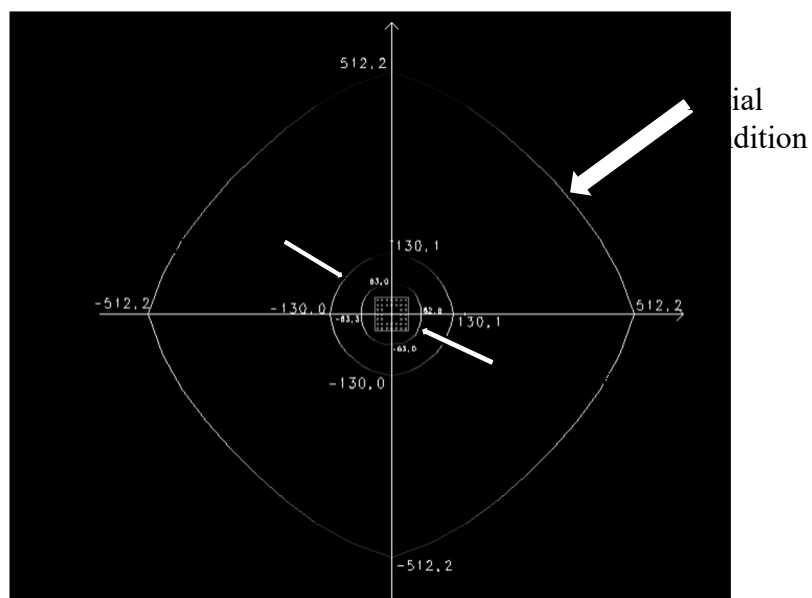
**Comparação das Curvas de Interação  
 $M_x$  e  $M_y$  para  $N_d = 2100 \text{tf}$**
