**ASOCIACIÓN LATINOAMERICANA DE CONTROL DE CALIDAD
PATOLOGÍA Y RECUPERACIÓN DE LA CONSTRUCCIÓN
BOLIVIA**

**Coloquio
Internacional
de Patología Estructural**

COLAPSO ESTRUTURAL

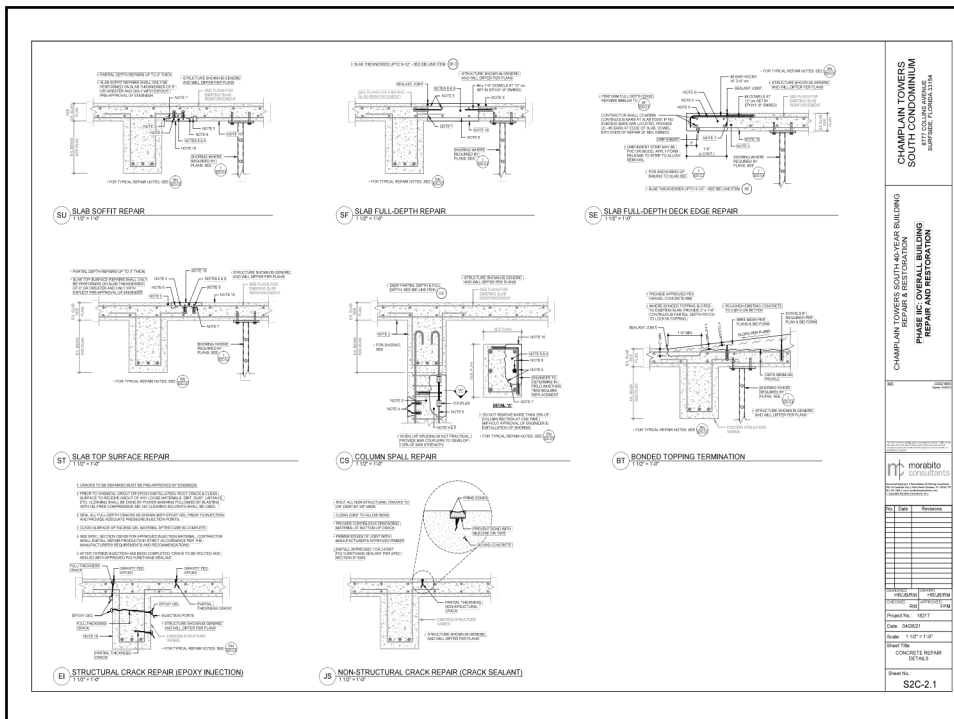
" The Pool Deck and Entrance Drive areas were reviewed

Many of the existing pavers on the pool deck are cracked

The joint sealant was observed to be beyond its useful life and are in need to complete replacement

The failed waterproofing is causing major structural damage to the concrete structural slab below these areas "

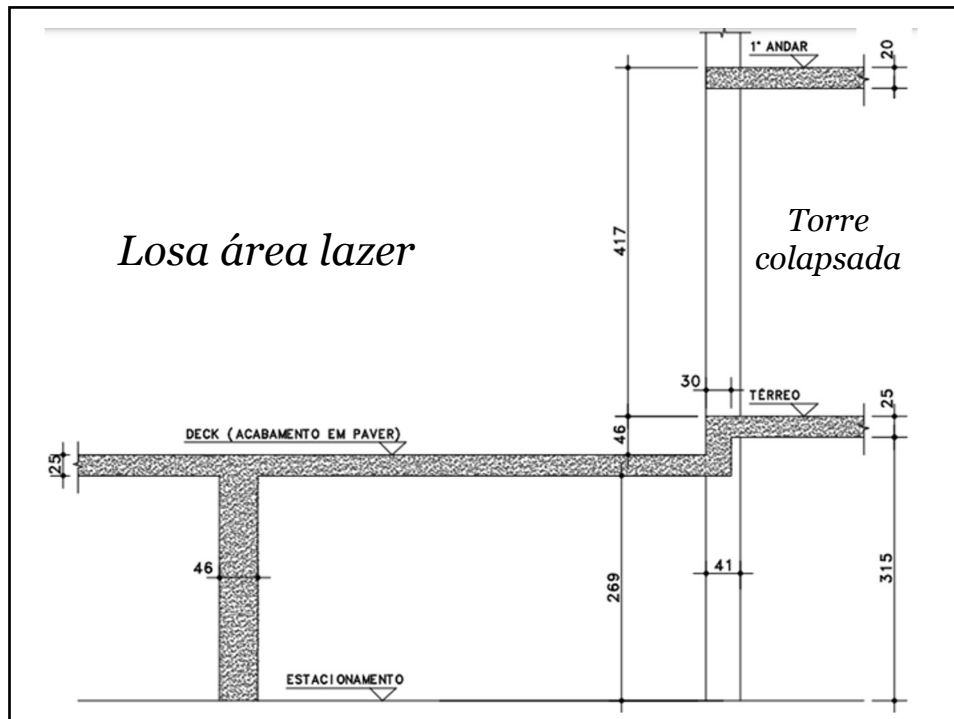
- ✓ Columnas de hormigón desde aparcamiento hasta tercer piso: 6,000psi (41.4 MPa)
- ✓ Losas de hormigón hasta 8 pisos: 4,000psi (27.6 MPa)
- ✓ Refuerzo de la columna 61x61cm : 12Ø32 → $A_s = 98.28\text{cm}^2$
→ $\rho = 2.64\%$
- ✓ Refuerzo de la columna 41x41 cm : 8Ø36 → $A_s = 80.48\text{cm}^2$
→ $\rho = 4.79\%$
- ✓ Refuerzo de la columna 36x46 cm: 10Ø32 → $A_s = 81.9\text{cm}^2$
→ $\rho = 4.95\%$
- ✓ Losas de espesor: 25cm (Lazer), 20cm (torre)
- ✓ Losas, refuerzo inferiores: Ø12.7 C/30cm → $\rho = 0.17\%$ (Planta baja), 0.19% (Torre)
- ✓ No se encuentra en el diseño ningún detalle de armadura de punzonamiento

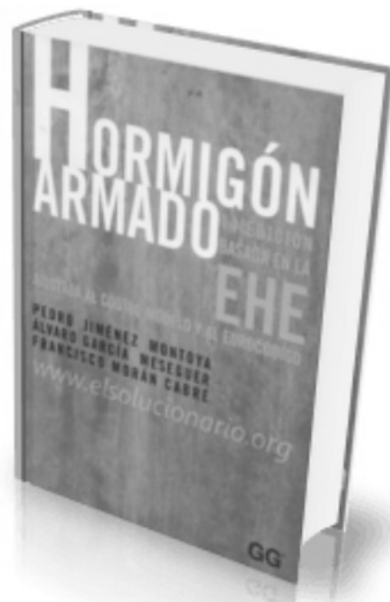
apartado 20.12

“Punzonamiento”
