*Fire and Collapse of the Wilton Paes de Almeida
Building
Lessons Learned*

Paulo Helene
*PhD Engenharia Director
IBRACON Technical Director
Prof. Universidade de São Paulo
ALCONPAT Internacional, past President
Member fib (CEB-FIP) Model Code for Service Life Design*

**Fire and Collapse of the Wilton Paes
de Almeida Building**
Lessons Learned
53 years old
collapsed in 1 h 20 min

São Paulo May, 1st 2018

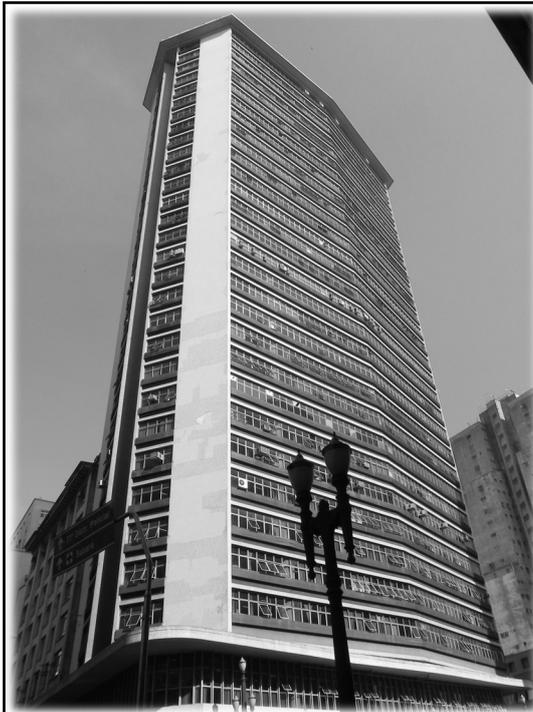
ANDRAUS Building

***32 storey office building
115 m (377,3 feet)***

Fire: 24 Feb. 1972

***Duration: 4 h
240 minutes***

***Nowadays: in use
Not collapsed!***

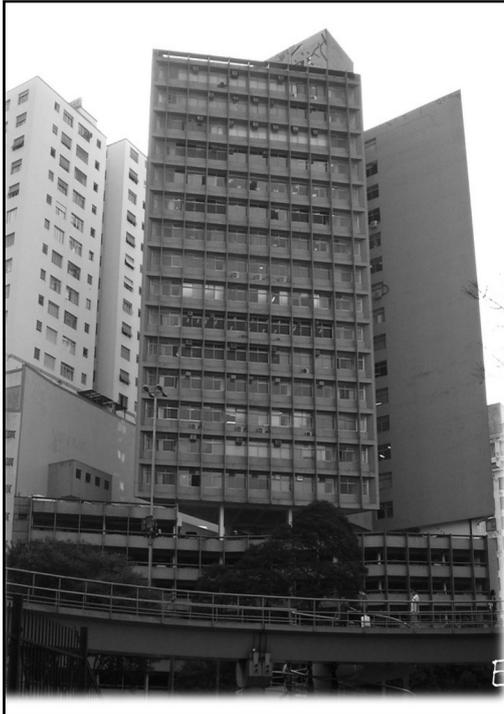
JOELMA Building

**26 floors
10 parking garage floors
+ 15 office storey**

Fire: 1 Fev. 1974

***Duration: 6,5 h
390 minutes***

***In use
Not colapsed!***

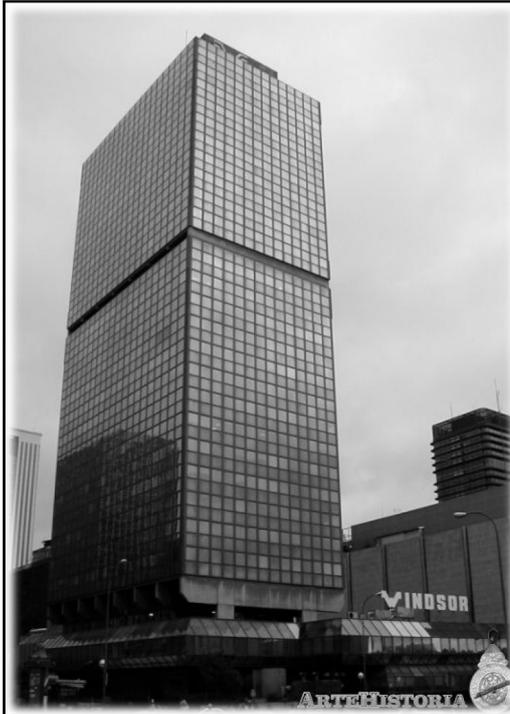
WINDSOR Building

**Madrid, Spain
2005
steel-concrete structure**

**37 floors
5 parking garage floors
+ 31 office storey**

Fire: 12 Fev. 2005

**Duration: 16 h
960 minutes**

**Partial damage (steel)
implosion**

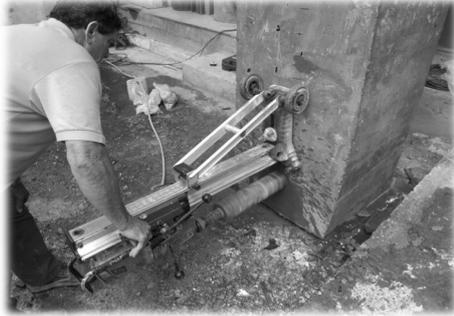
cores withdrawal

after 8 years

140 MPa (20,000 psi)

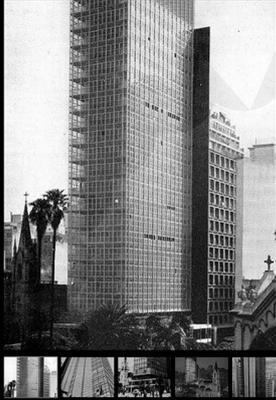
ESTRUTURA: Metálica com lajes em concreto

ESTADO DE CONSERVAÇÃO: Péssimo

Structure: Steel columns with concrete slabs

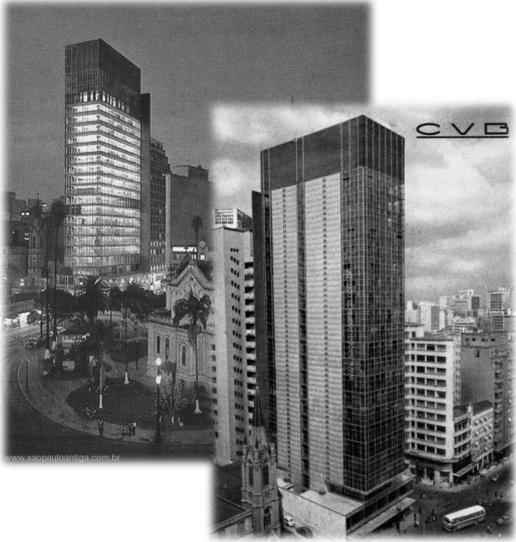
**Structure: Steel
columns with
concrete slabs**

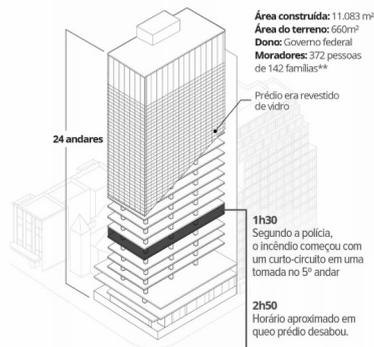
Incêndio em prédio de SP foi causado por curto-circuito em tomada no 5º andar, diz secretário

Em depoimento, moradora disse que fogo começou em tomada onde estavam ligados TV, micro-ondas e geladeira.

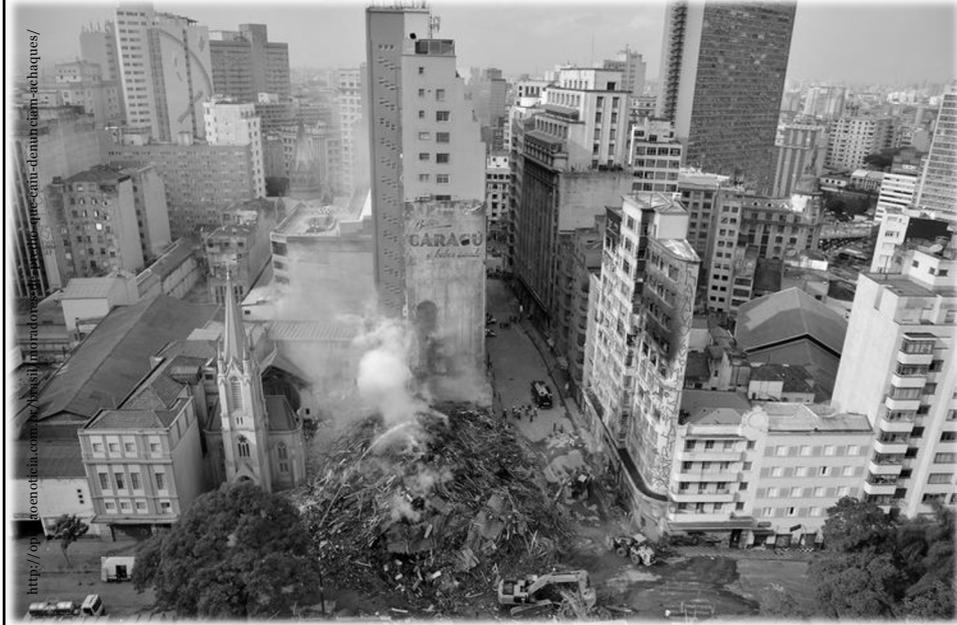
After collapse...

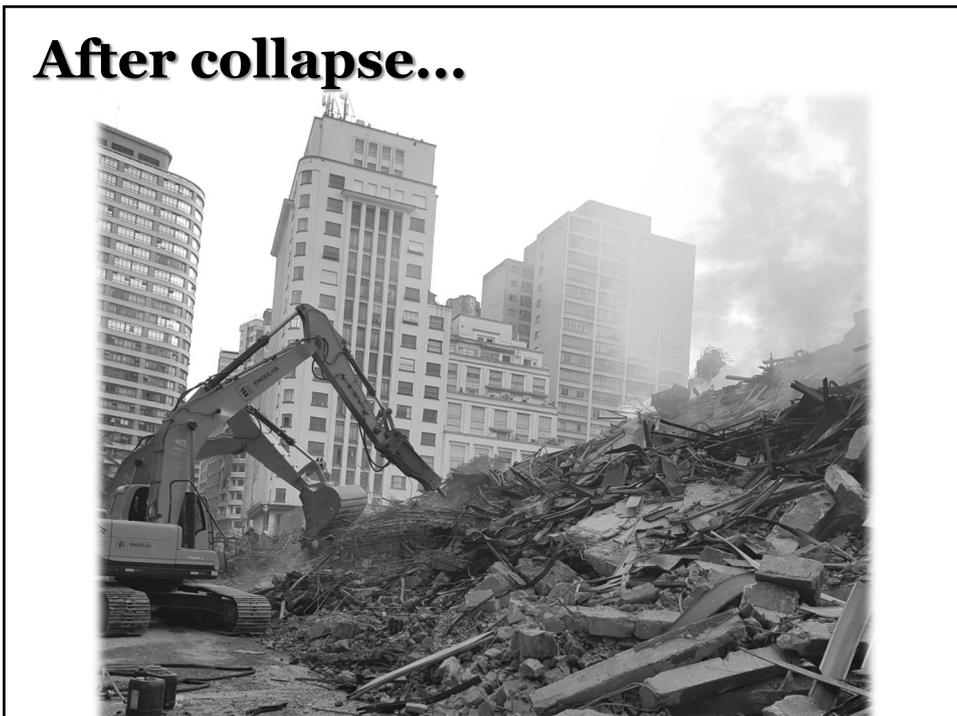
After collapse...

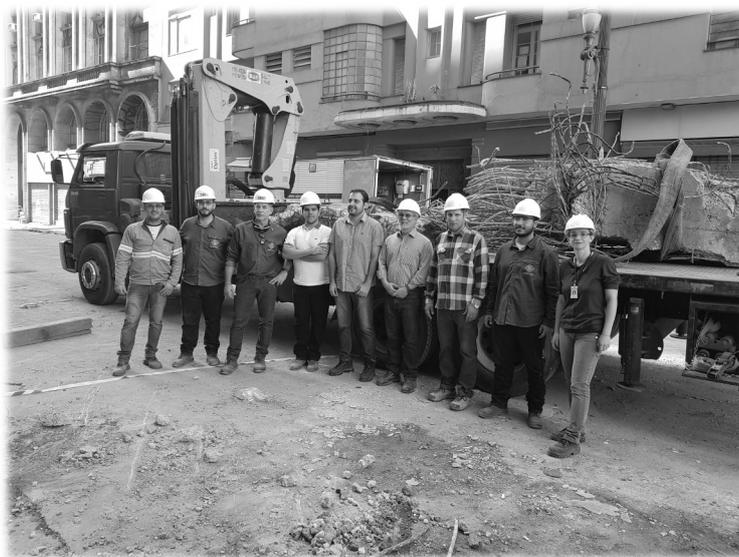
Colecting samples to test

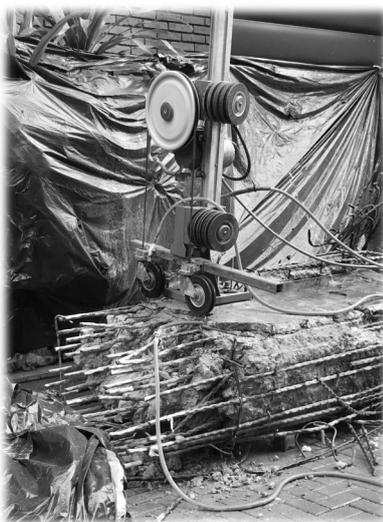
Sample preparing

- ✓ Rebar cut with acetylene torch
- ✓ Concrete cut with diamond wire

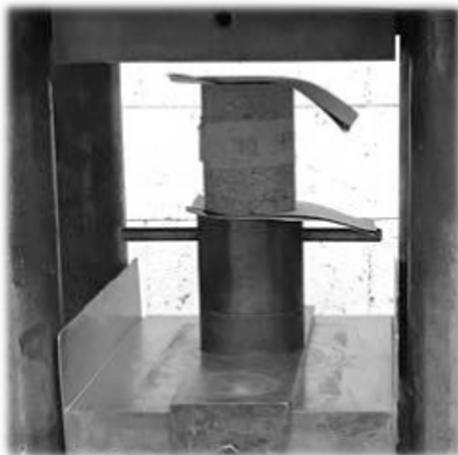
Compressive strength

✓ Average strength: 21,8 MPa
(3,200 psi)

$f_{ck} = 15 \text{ MPa}$
(2,200 psi)

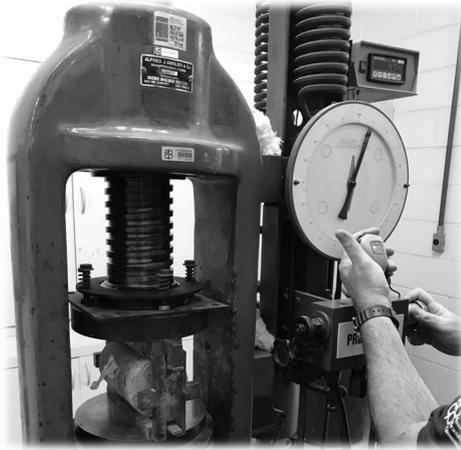
Tensile strength

✓ Average strength: 2,1 MPa
(300 psi)

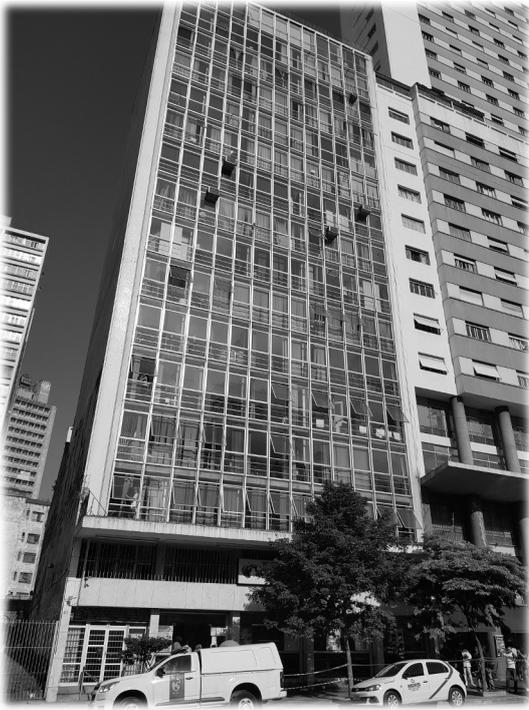
**Neighbor Building at
Av. Rio Branco
in front of church:
Glass Windows
Façade**
